Navajo Abandoned Uranium Mine

Site Screen Report

Mine Name: Harvey Blackwater Claim (South)
Mine ID: 238

Weston Solutions, Inc.

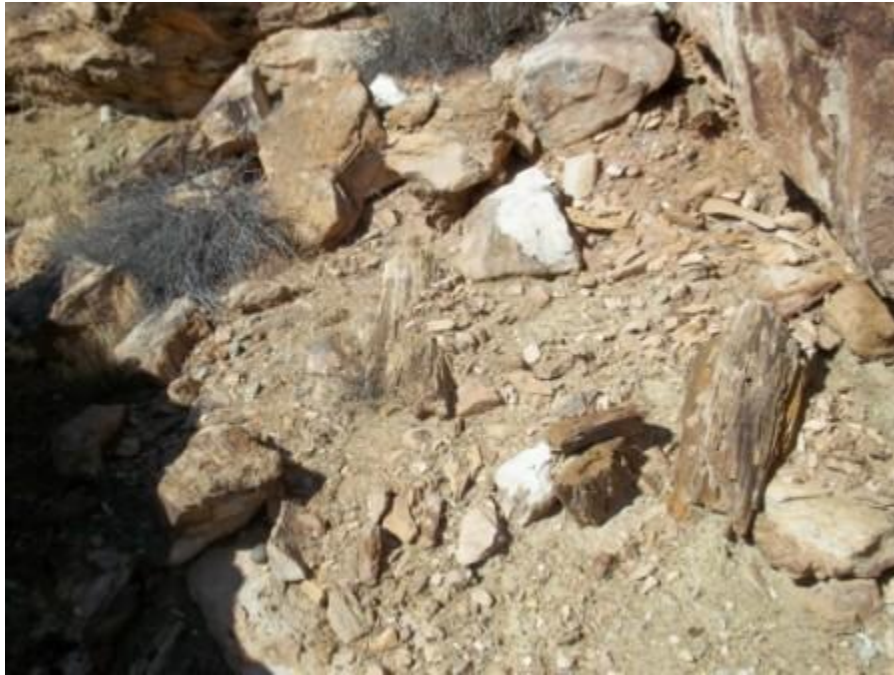
Photo 1

Mine Site #238 – Elevated gamma

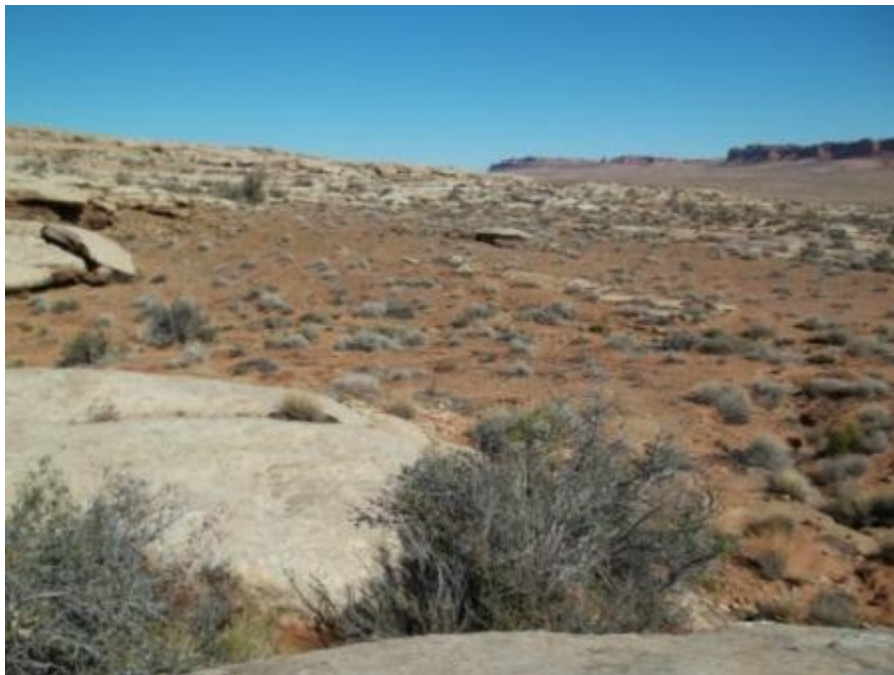
Photo 2

Mine Site #238
